Elk River TMDL Development Update and Overview of the Draft Upper Elk River Sediment Source Analysis

June 28, 2011
Eureka, CA

Adona White, PE
Basin Planning Unit

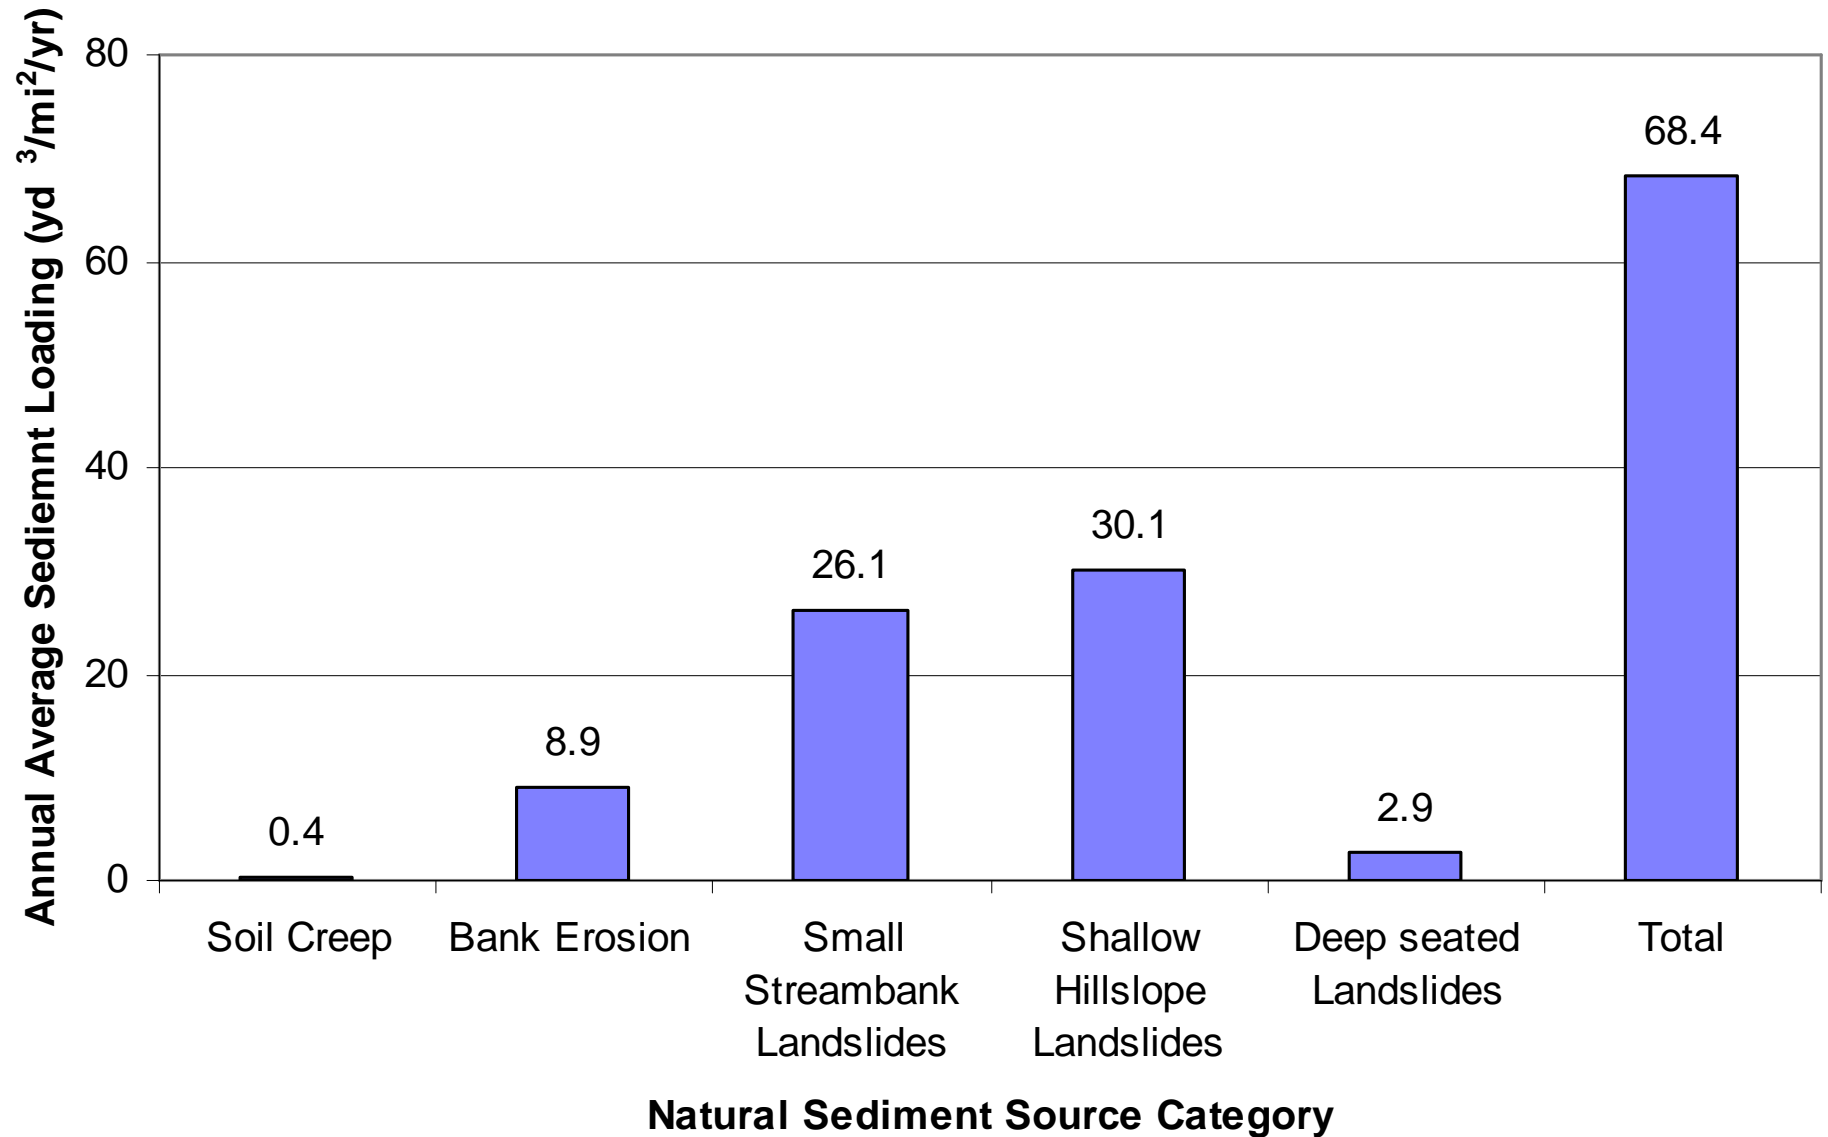
Natural Sources Summary

Sediment Source	Data Sources Relied Upon / Approach
Natural	Soil Creep	Literature
	Bank Erosion	Field surveys; natural drainage density estimate
	Small Streambank Landslides	Field surveys; natural drainage density estimate
	Shallow Hillslope Landslides	Areas not harvested in past 15 years
	Deep seated Landslides	CGS mapped active features; Palco WA rates

TMDL		Palco WA	
	Source Category	1988-2000 (yd ³ /mi ² /yr)	Source Category	1988-2000 (yd ³ /mi ² /yr)
Natural	Soil Creep	0.44	Soil Creep	52
	Bank Erosion	9	Bank Erosion	38
	Shallow Landslides	26	Shallow Landslides	68
	Streamside Landslides	30	Streamside Landslides	276
	Deep Seated Landslides	0	Deep Seated Landslides	3
	Natural Total	66	Natural Total	437
Management	Low Order Channel Headward Incision	24		
	Soil Creep	1		
	Bank Erosion	52	Bank Erosion	38
	Streamside Landslides	272	Road-related Streamside Landslides	162
	Open-slope Shallow Landslides	182	Open-slope Shallow Landslides	144
	Road-related Shallow Landslides	237	Road-related Shallow Landslides	168
	Discharge sites	59	Gullies	28
	Skid Trails	15		
	Post-Treatment Discharge Sites	3		
	Road surface erosion	118	Road surface erosion	32
	Harvest Surface Erosion	5	Surface Erosion	6
	Management Total	967	Management Total	579
	Total Loading	1,033	Total Loading	1,016

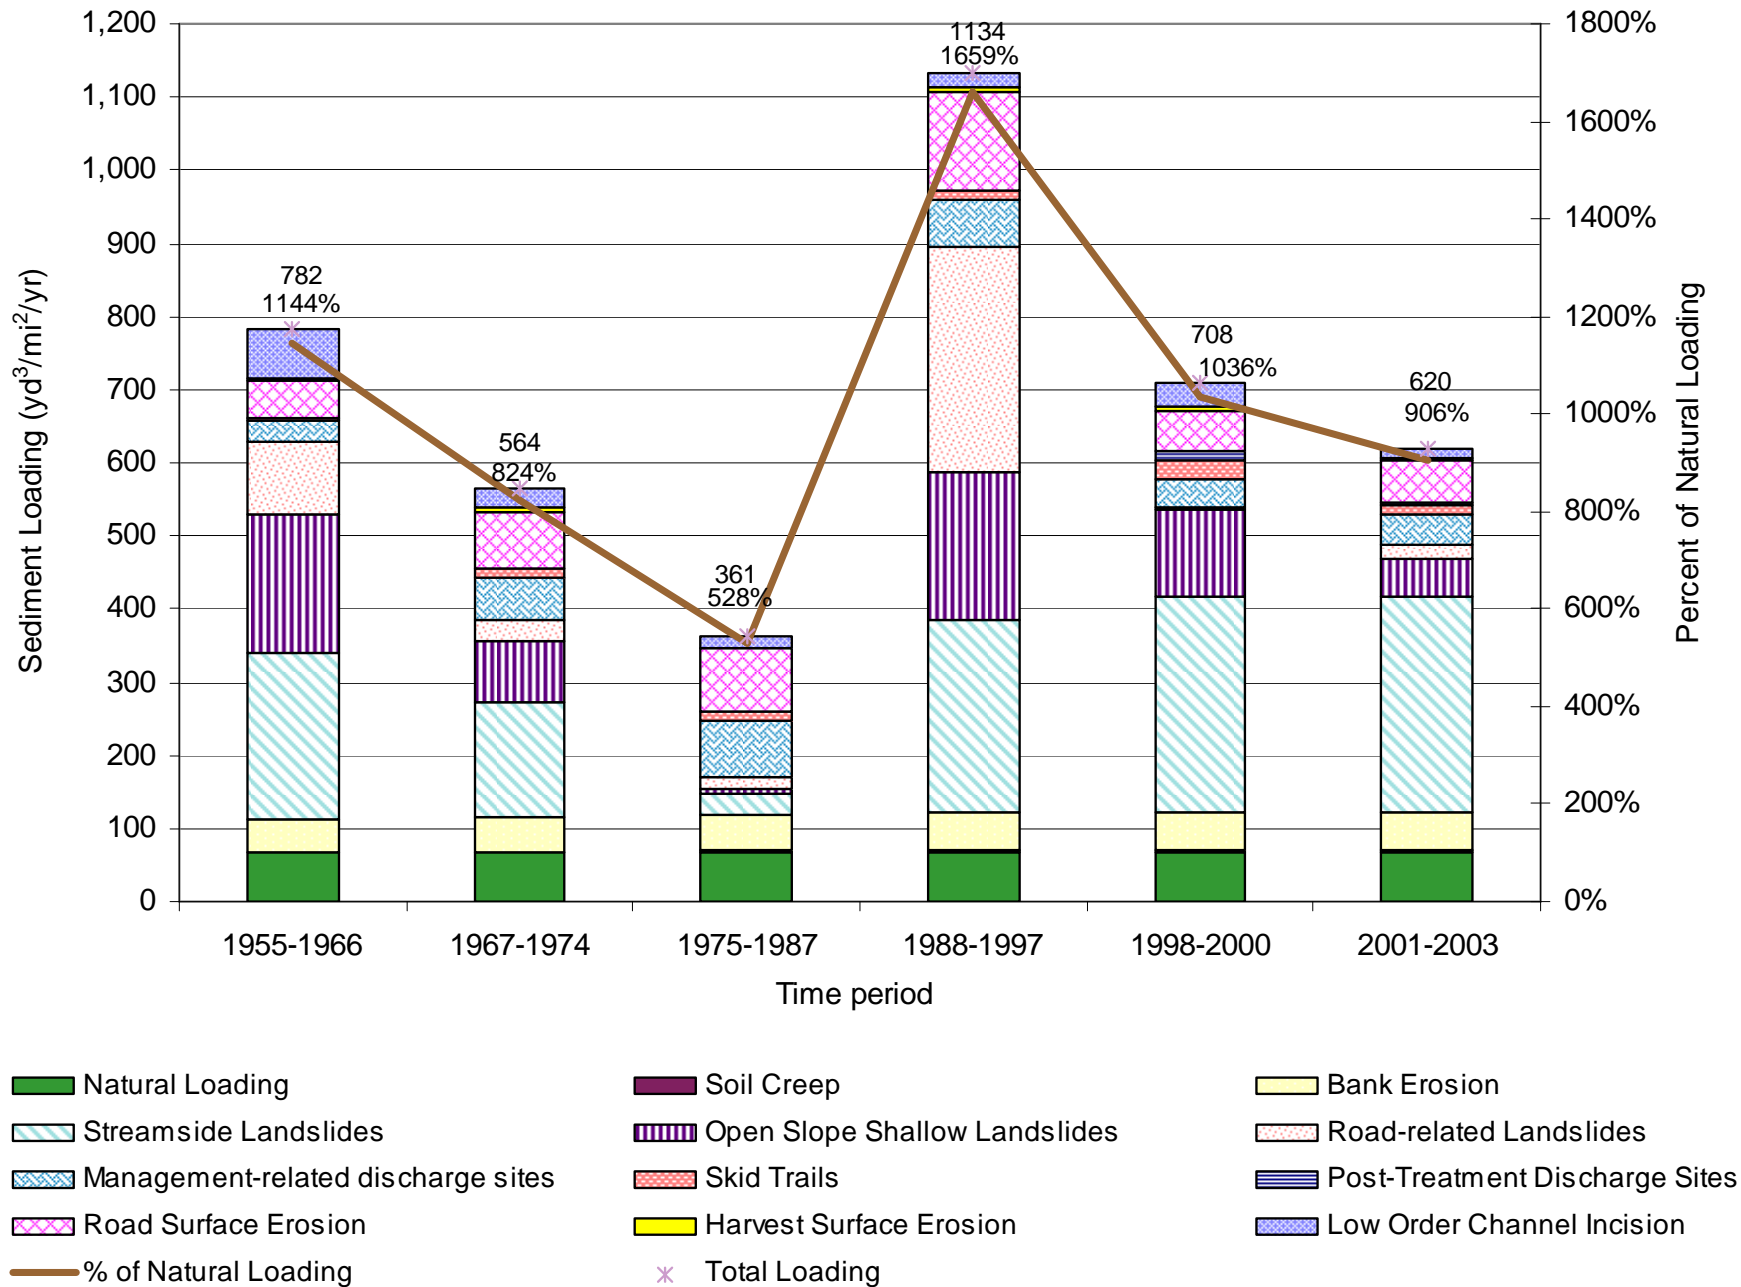
Management Sources Summary

Sediment Source	Data Sources Relied Upon / Approach
Management	Low Order Channel Incision	Field-based estimates of managed and natural drainage density; assumed 75% occurred in 1950's and 5% in each subsequent decade
	Management-Related Soil Creep	Soil creep to management-induce channel network
	Management-Related Bank Erosion	Field surveys in managed study sub-basins; managed drainage density estimate; subtracted natural loading
	Management-Related Open Slope Shallow Landslides	Sub-basin specific landslide inventory data from Palco WA and 2005 ROWD; non-road-related slides, includes some skid-related slides
	Road-related Landslides	Sub-basin specific landslide inventory data from Palco WA and 2005 ROWD

Sediment Source	Data Sources Relied Upon / Approach
Management	Management-Related Streamside Landslides	Field surveys in managed sub-basins in Freshwater Creek; applied to natural drainage density estimate assuming bank erosion captured features in management-induced network; subtracted natural loading
	Management-Related Discharge Sites	Sub-basin specific site inventories from Palco WA, HRC CAO reports, GDRC WDR reports, BLM reports
	Post-Treatment Discharge Sites	Compiled monitoring results from BLM, HRC, and GDRC from sites treated in Elk River.
	Skid Trails	Compiled findings from Elk River skid-related inventories on BLM and HRC lands to estimate loading from skid sties not included in Management Discharge Site inventories
	Road surface erosion	Sub-basin road densities & surface condition based on Palco WA and ROWD; unit loading based upon Palco ROWD
	Harvest surface erosion	Estimated harvest history in clear-cut equivalents based upon CDF, Palco WA, and Palco ROWD; unit loading based upon Palco WA

Percent over Natural Loading	1,576%	Percent over Natural Loading	232%
